Gallery of goofs

*This case history reviews an all-too-frequent oversight in the design of plastic parts with tapered pipe threads, and describes how the resulting product failure was corrected with a simple design modification. The author is Glenn L. Beall, president of Glenn Beall Plastics and former design editor of *Plastics Design Forum* magazine.*

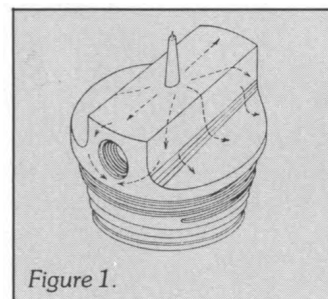
Figure 1.

The filter body that accepted the threaded tapered pipe fittings was injection molded in a medium-impact ABS plastic. The single-cavity production mold was top-center-sprue-gated (Figure 1).

Considering the location of the gate and the flow of the melt (Figure 1), it is obvious that the filter bodies contained weld lines in the inside thread in the area of the failures. Careful examination of returned units also indicated that all of the defects had at least started in the weld line below the thread. Inspection of unsold filter bodies molded at the same time, as well as observations made on the failed units, indicated that the parts had been properly molded. The weld lines were completely closed and well-knitted.

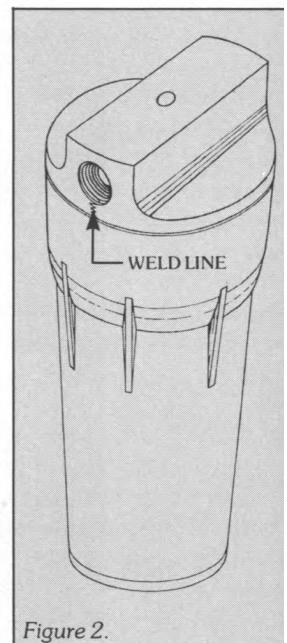
Examination of defective units that were returned revealed that all of the failures were the result of stress

cracks in the inside tapered pipe threads used for attaching the unit to the central plumbing system. In all cases, the failures were located below the thread as shown in Figure 2. None of the returned units were of the type adapted to be used with soldered-copper solvent-bonded plastic pipe.

It was concluded that the stress cracks were due to

overzealous tightening of the tapered pipe thread fittings. In retrospect, overtightening was an anticipatable misuse prompted by a desire to avoid leakage at the fitting. It was also speculated that overtightening was encouraged by the fact that during assembly the inside and outside threads gradually became tight with no positive indication of when a seal had been made. Metal fittings of this type abruptly become too tight to turn further. Thermoplastic parts with inside tapered threads are capable of expanding as the outside tapered thread is driven deeper into the inside tapered thread. Figure 3a illustrates this condition.
