Gallery of goofs

This is the second in a continuing series that reports on errors of judgment made in the design and engineering of actual plastics parts and products.

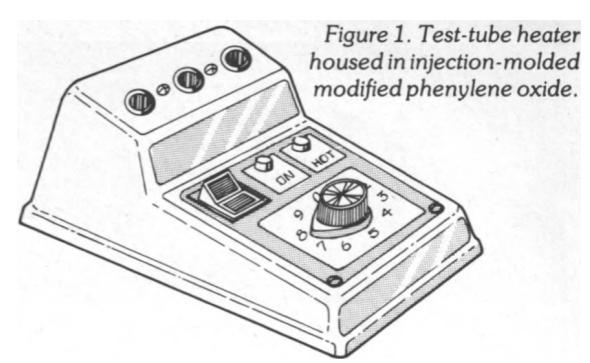
The entire assembly is mounted on a steel plate, and the unit is housed in an injection-molded modified-PPO housing. The housing is a simple shell that provides the necessary aesthetics and ensures a suitable display area for the off/on switch, indicating lights and timer (Figure 1).

Shortly after the initial introduction of the product, users registered complaints about the housing's tendency to crack between the three test-tube heating wells. These failures did not prevent the unit from performing its intended function, but the cracks did destroy the nice appearance of the housing.

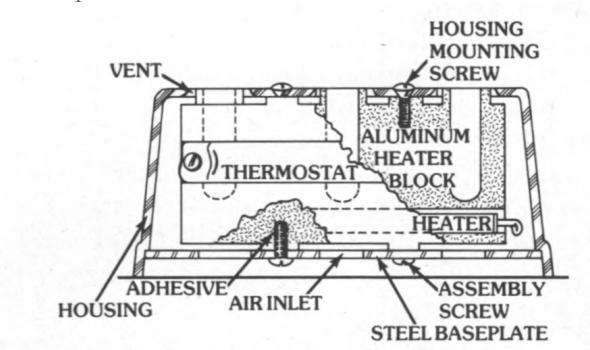
Figure 2. Schematic of test-tube-heater components.

The logic in using the adhesive was good; however, the well-meaning person who applied it had not stopped to consider the possibility of an incompatibility between the adhesive and modified PPO. That was very understandable, as the adhesive itself never came into actual contact with the plastics housing, as can be seen in Figure 2.

The test-tube heater was designed to allow all of the components to be assembled on the metal baseplate. The plastics cover was not placed in position until after the unit was totally assembled and tested. The adhesive was added to the assembly screws on the baseplate in order to discourage anyone from inadvertently removing the baseplate instead of the plastics housing to service the unit.

Actual testing of full assemblies under normal usage conditions revealed that the adhesive dispersed a very small amount of volatile gas during the first few hours of operation. This gas followed the normal flow of cooling air through the assembly, which brought the volatile gas in contact with the inside surfaces of the plastics housing. These volatile gases only attacked the plastics housing in the two relatively high-stressed areas around the upper two flathead-screw holes that were used to attach the housing to the rest of the assembly. The two screw holes on the lower level were unaffected, since the volatile gas did not contact that area in the assembly.

In accordance with the material supplier's recommendations, a different adhesive was chosen and its use was written into the manufacturing specifications. After accelerated testing, the product was reintroduced. Those customers who had cracked housings were provided with replacements. Cracks in the test-tube heater housing are no longer a problem.

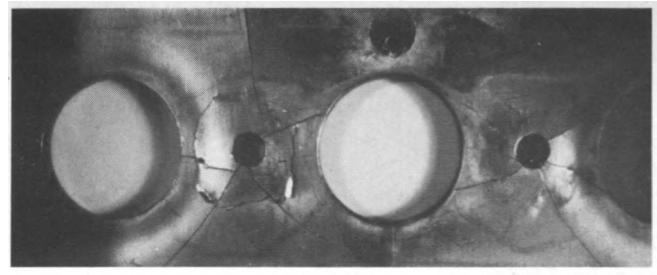
Careful examination of the actual fracture surfaces seemed to indicate a stress-cracking pattern (Figure 3) characteristic of a chemical attack.

Figure 3. Stress-cracking pattern indicative of a chemical attack.

By this time, the product had been discontinued and the assembly line shut down. An actual inspection of the assembly line did reveal, however, a small can of adhesive of the type used to hold metal screws in place. This type of adhesive was not listed in the manufacturing instructions. A series of probing questions revealed that the adhesive had been added as an afterthought.
